## **Preliminary Report**

**Accident involving Air India's B787-8 aircraft bearing registration VT-ANB  
at Ahmedabad on 12 June 2025**

**Government of India  
Ministry of Civil Aviation  
Aircraft Accident Investigation Bureau**

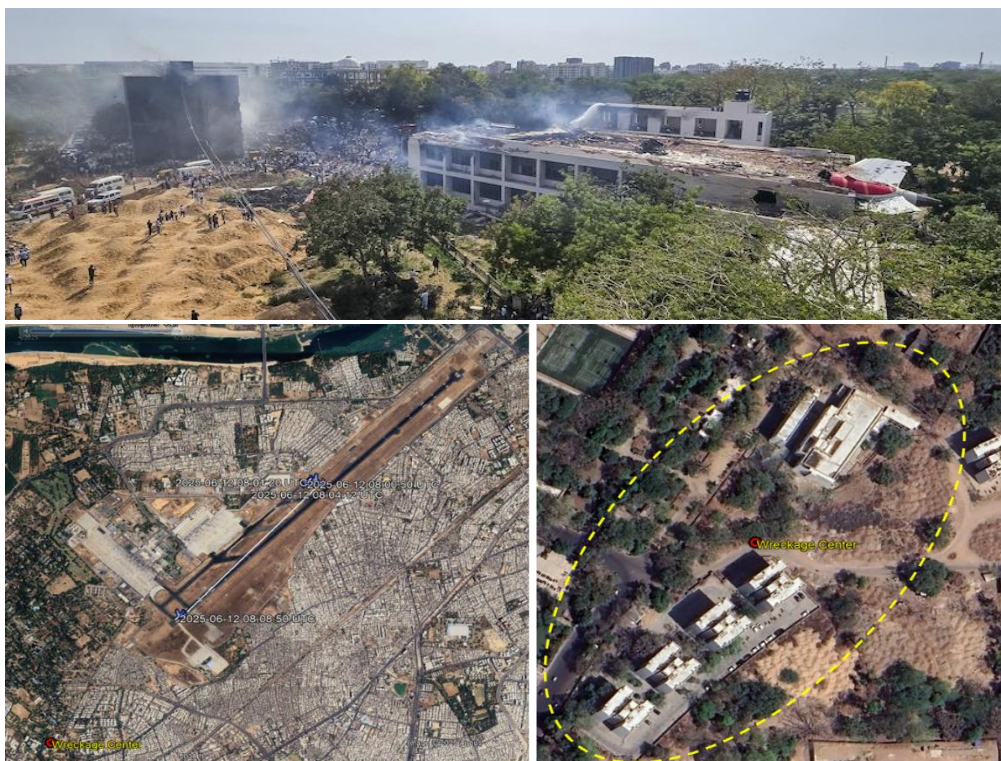
The Aircraft was destroyed due to impact with the buildings on the ground and subsequent fire. A total of five buildings shown in the figure below were impacted and suffered major structural and fire damages.

Figure 1 Accident Site with respect to airport (left) and debris field

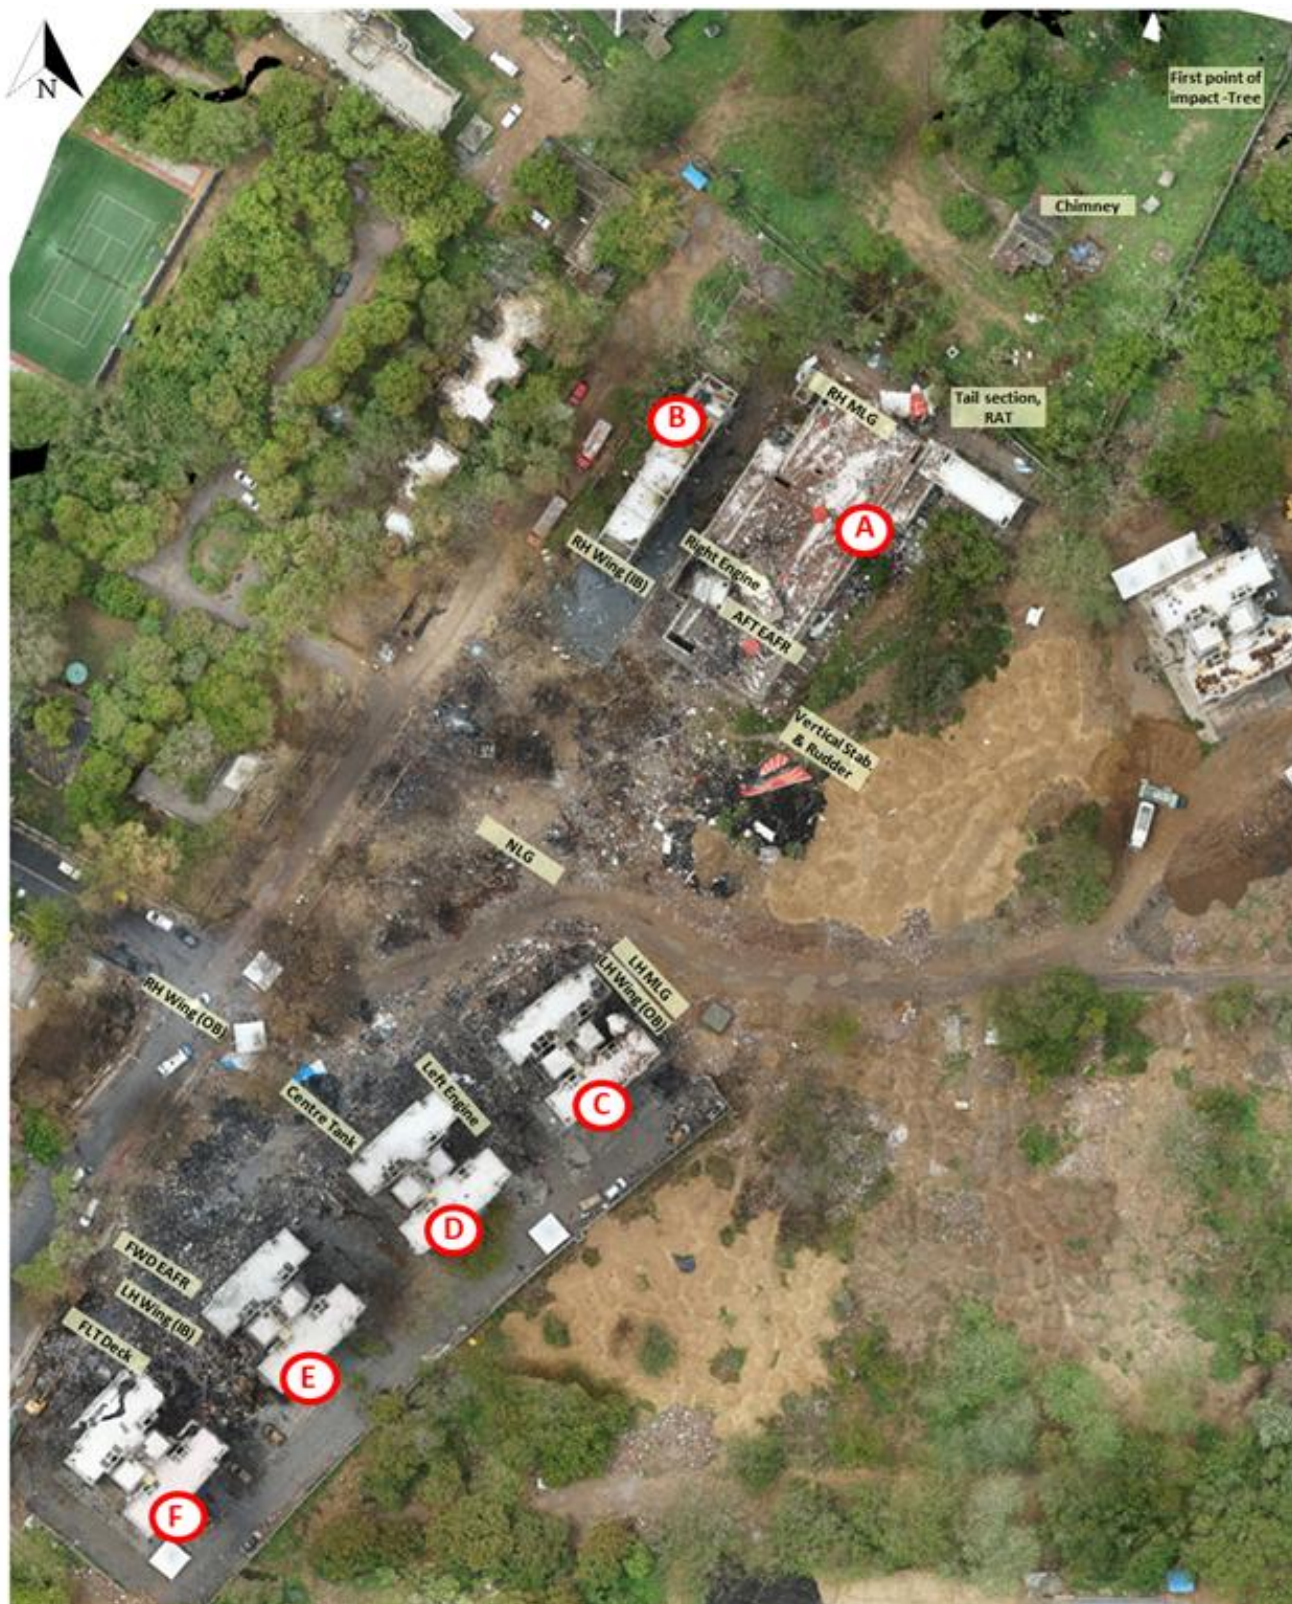
After takeoff, the aircraft impacted the BJ Medical College hostel which is 0.9 NM from the departure end of Runway 23. The Emergency Locator Transmitter (ELT) was not activated during this event. The wreckage, from the first impact point till the last identified aircraft item, was distributed in an area of approx. 1000 ft \* 400 ft. A layout of the crash site has been given in Fig. 2 indicating the significant parts of the aircraft. The buildings at the wreckage site have been labelled alphabetically from A-F in the layout for easy reference.

Figure 2 Wreckage layout

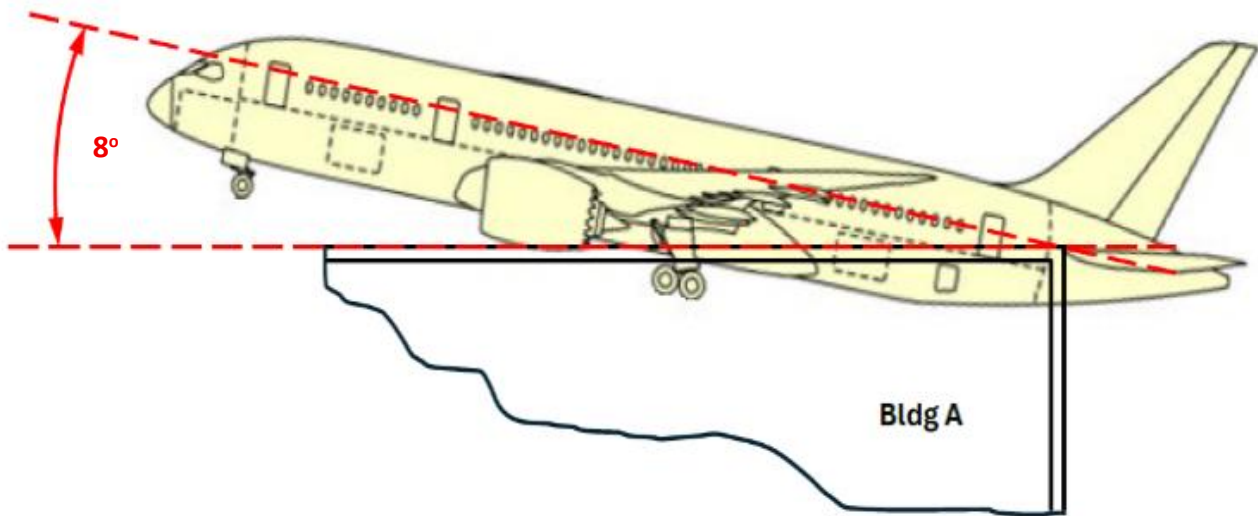
As the aircraft was losing altitude, it initially made contact with a series of trees and an incineration chimney inside the Army Medical Corps compound before impacting the northeast wall of the Building A. The distance between the tree on which the aircraft made its initial contact and the point on the Building A where the aircraft impacted is 293 ft. As the

Figure 3 Aircraft attitude at the time of impact with Building A

aircraft moved forward, it continued fragmenting and collided with other structures and vegetation. The impact witness marks on the building and airplane indicated a likely nose-up attitude (about 8°) and wings level.

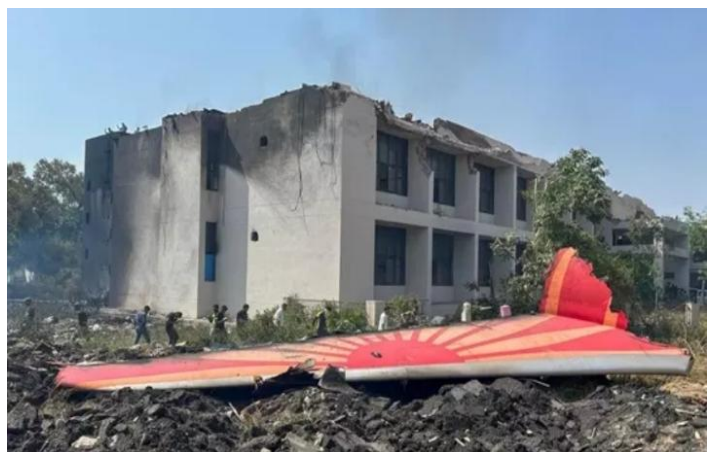
The vertical stabilizer (*fig. 5*) separated from the aft fuselage and came to rest about 200 feet south of the initial point of contact with the Building A. The tail section and the RH Main Landing Gear (MLG) of the aircraft were found embedded in the northeast wall of the Building A while the rest of the airplane continued its forward movement.

Figure 5 Vertical Stabilizer adjacent to Building A

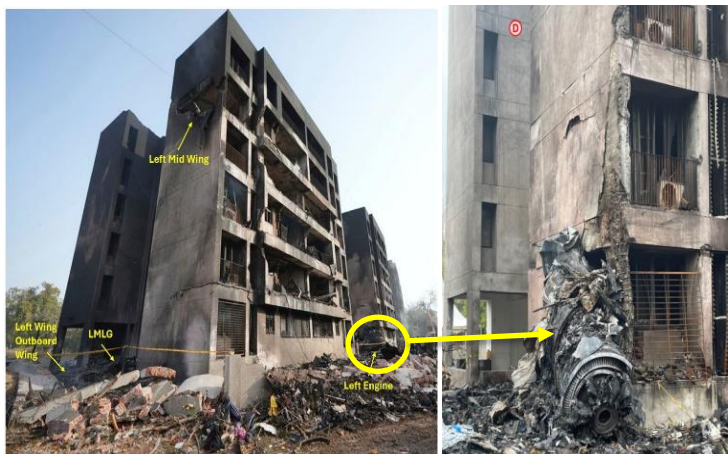
The left engine (*fig.8*) got separated from the airplane and struck the north corner of Building D at the ground level where it remained and was roughly perpendicular to the right engine resting position, at heading of approx. 326 degrees. The wall was pushed into the

building and the northwest building column was damaged such that portions of the concrete

Figure 8 LH Engine

were missing and exposing the internal metal rebar. The engine, remaining portions of attached cowling, and the surrounding area were heavily damaged by fire.

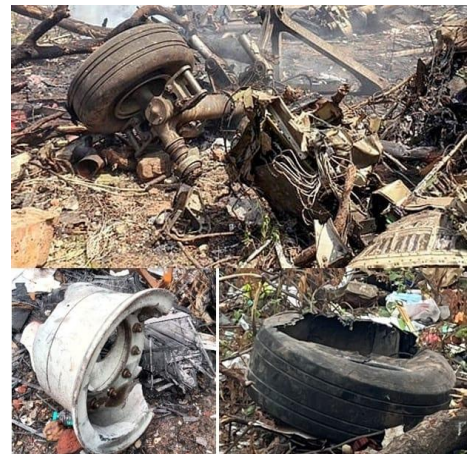
The nose landing gear (NLG) (*fig. 9*) was found on the ground about 307 feet southwest from the initial point of contact with Building A.

Figure 9 Nose Landing Gear

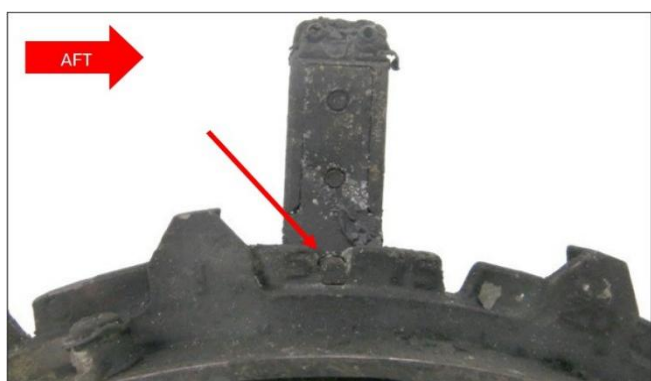
Figure 11 Flap Handle Lever

The flap handle assembly (*fig.11*) sustained significant thermal damage. The handle was found to be firmly seated in the 5-degree flap position, consistent with a normal takeoff flap setting. The position was also confirmed from the EAFR data. The landing gear lever was in “DOWN” position. (*fig.12*)

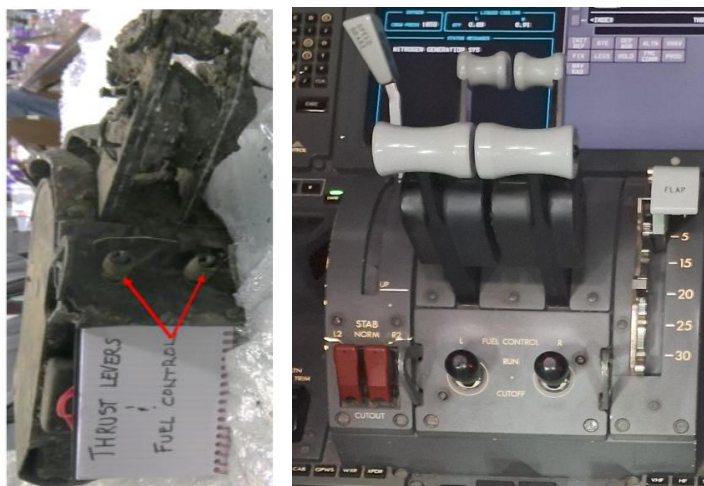
The thrust lever quadrant sustained significant thermal damage. Both thrust levers were found near the aft (idle) position. However, the EAFR data revealed that the thrust levers remained forward (takeoff thrust) until the impact. Both fuel control switch were found in the “RUN” position. (*fig.13*) The reverser levers were bent but were in the “stowed” position. The wiring from the TO/GA switches and autothrottle disconnect switches were visible, but heavily damaged.

Figure 13 Thrust Lever Quadrant & Fuel Control Switch

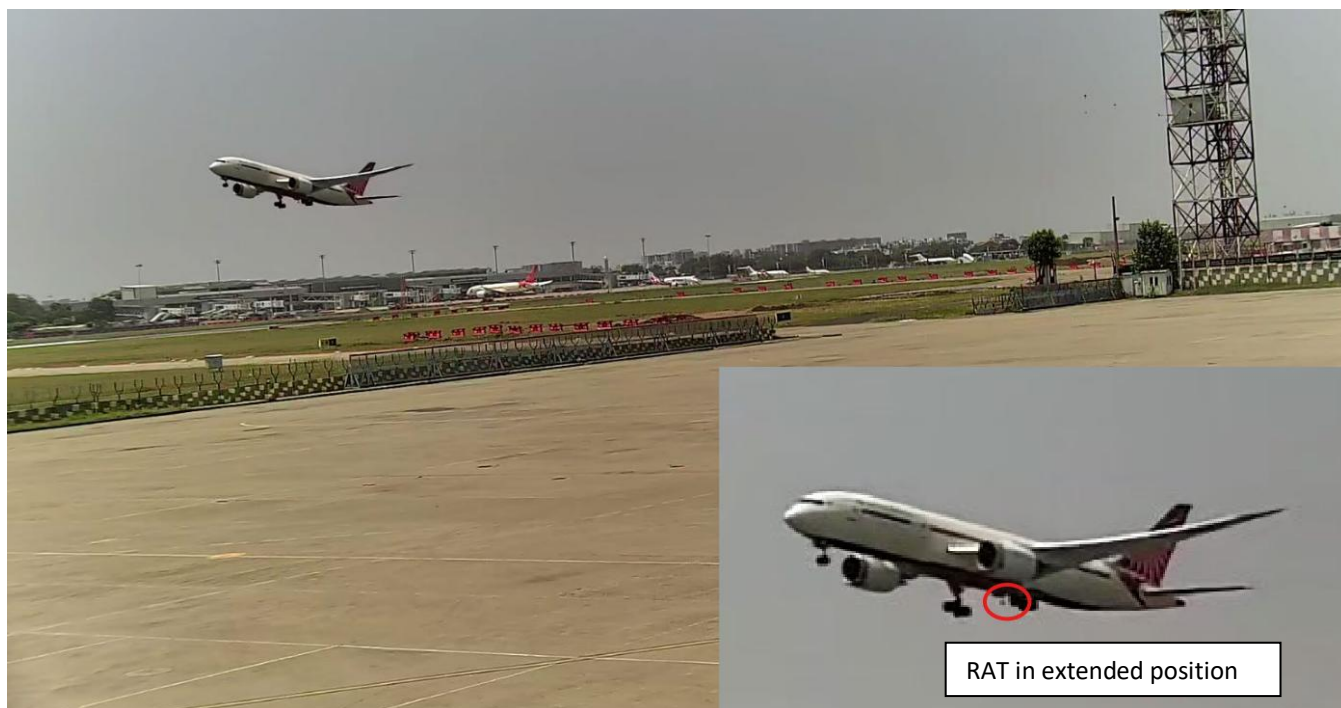
The CCTV footage obtained from the airport showed Ram Air Turbine (RAT) getting deployed during the initial climb immediately after lift-off (*fig. 15*). No significant bird activity is observed in the vicinity of the flight path. The aircraft started to lose altitude before crossing the airport perimeter wall.

Figure 15 CCTV screenshot of RAT Deployment
